SUBJECT: Gudaitis Lake Dam (MO 30702); Phase I Inspection Report

GUDAITIS LAKE DAM
Washington County, Missouri
Missouri Inventory No. 30702

Phase I Inspection Report
National Dam Safety Program

Gudaitis Lake Dam
Missouri
Washington
Unnamed Tributary of Clear Creek
18 July 1980

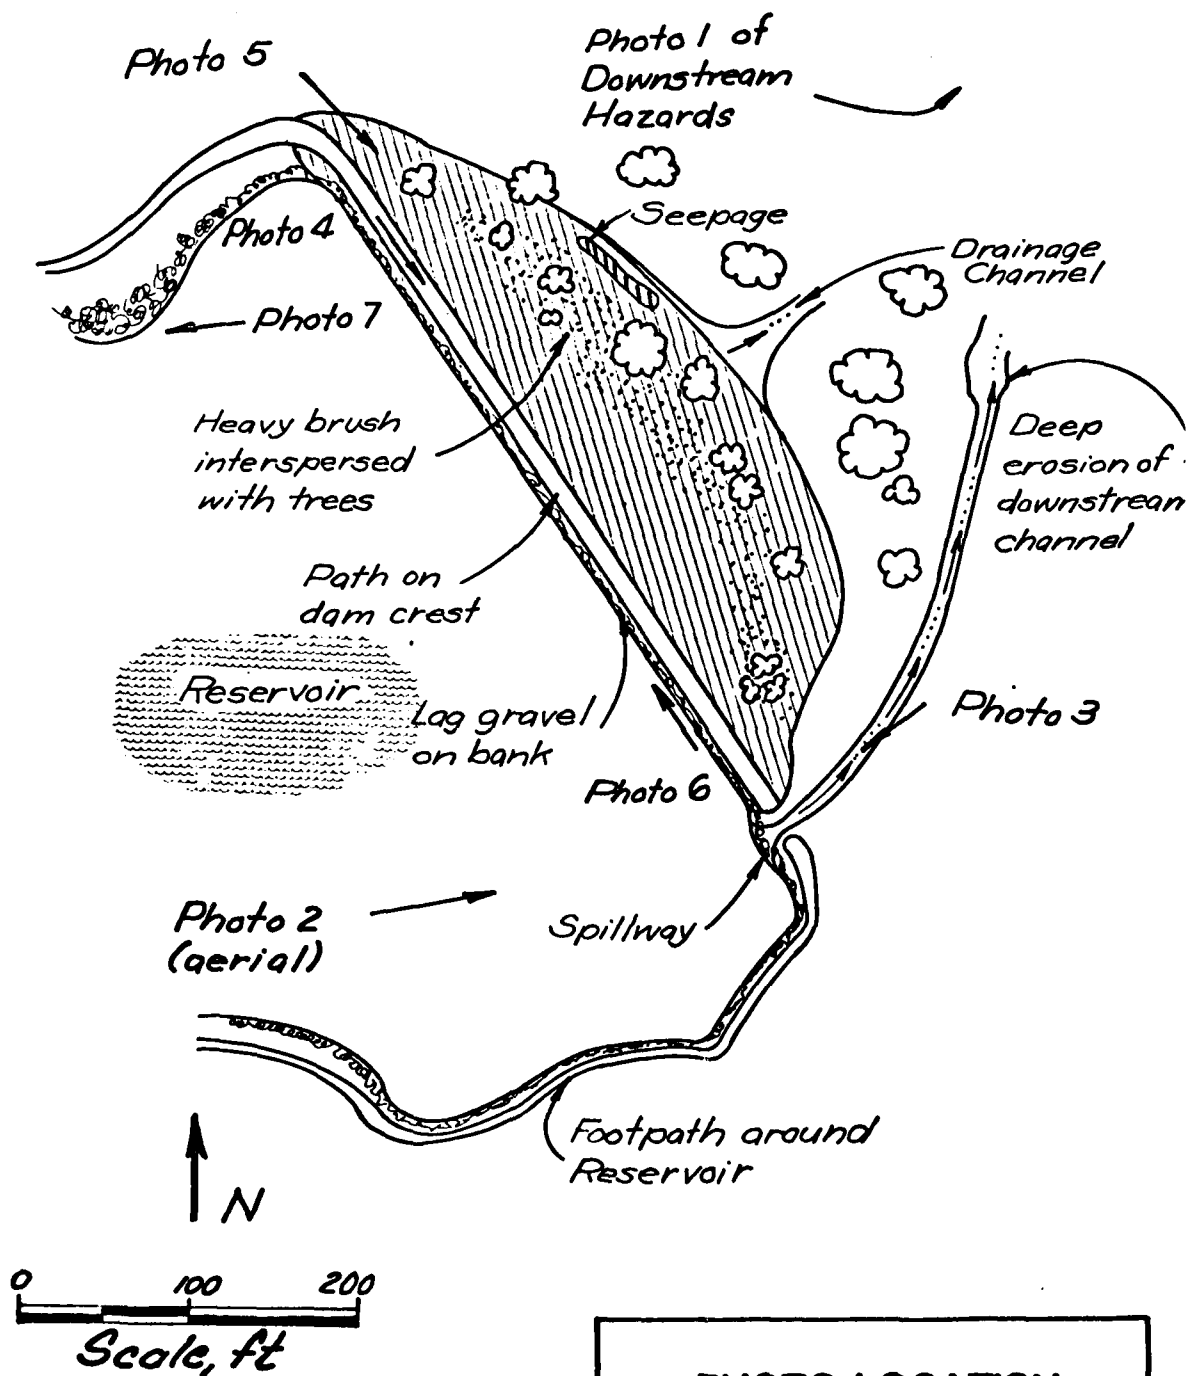
Fig. A-1

Seepage of approximately 1 to 2 gallons per minute was noted along the toe of the dam for about 40 ft, as shown in Fig A-1. The seepage is collected in a 1 ft wide, drainage ditch that runs along the dam toe. The ground in the area of seepage was spongy and swampy but very little movement of water was observed. The seepage did not appear to be transporting any soil particles.

The spillway discharge channel is in relatively good condition in the area near the dam. It is expected however, that erosion will continue in the downstream area indicated in Fig A-1, Appendix A. The channel is moderately erodible, and should therefore have erosion protection in the zone near the dam. The spillway and the discharge channel should be enlarged to carry the design flood, and the channel and spillway should be protected against erosion.
